May 2023 Issue 10

Stornoway Port Authority

Deep Water Terminal

Update on April works

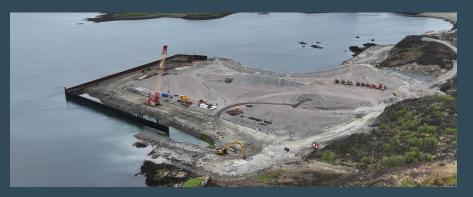
Tie rods fixed to quay

The contractor has started fixing tie rods to the back of the quay walls. This involves attaching brackets to the piles, then connecting the first part of the tie rods to the brackets. Once complete, the tie rods will provide support to the quay walls.
