# COMMUNITY NEWSLETTER

Stornoway Port Authority  
Deep Water Terminal

July 2023

Issue 12

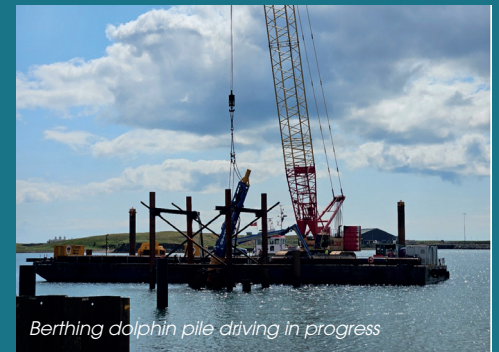
Berthing dolphin pile driving in progress

The berthing dolphin piles have been installed. The majority have been driven into seabed rock using a piling hammer attached to the crane. The remainder will be driven into rock in July. After this, rock anchors will be installed at the base of the piles to secure them to the seabed rock.

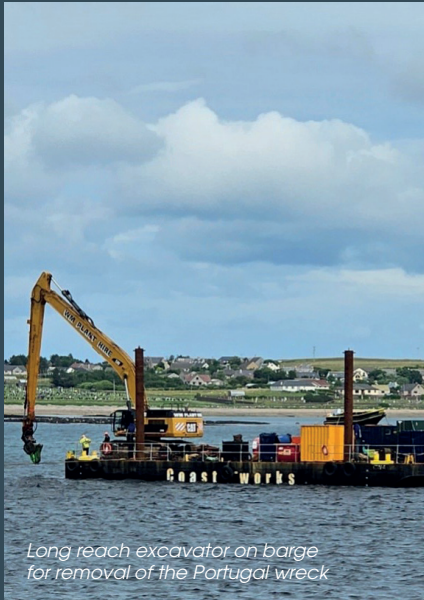
Long reach excavator on barge for removal of the Portugal wreck

Work to remove the remains of the Portugal wreck started in mid-July. The wreck will be cut into pieces using an underwater cutting tool attached to a long-reach excavator arm. The excavator will be mounted on a floating barge moored next to the wreck. The cut-up pieces will be recovered using a grab tool attached to a workboat and brought ashore. This work is expected to continue until the end of August.

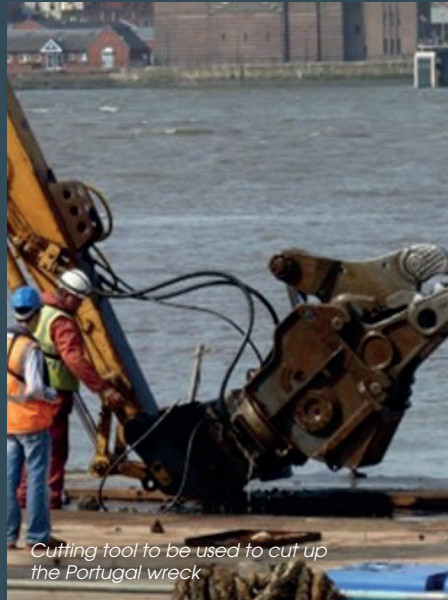
Cutting tool to be used to cut up the Portugal wreck

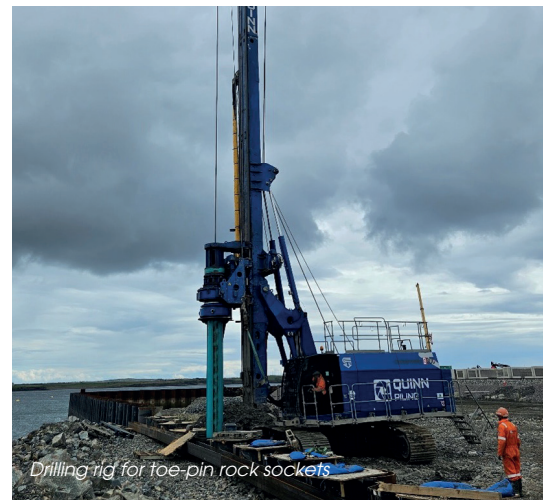
Drilling rig for toe-pin rock sockets

Quinn Piling have started work to secure these piles. This is done by drilling a hole 4m deep and 700mm in diameter into the rock below the piles. A 6m long steel tube called a toe-pin is then inserted into the hole and covered with 6.5m of concrete. These toe-pins stop the piles from moving.

Due to the seabed rock being at high levels near the shore, 16 of the linkspan berth piles have been driven into the seabed rock.
