# COMMUNITY NEWSLETTER

Stornoway Port Authority  
Deep Water Terminal

August 2023

Issue 13

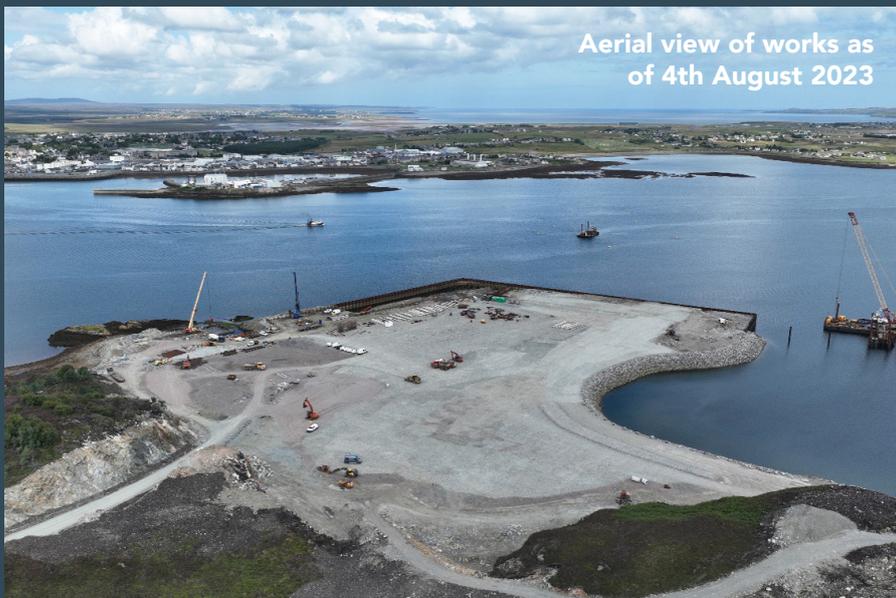
Aerial view of works as of 4th August 2023

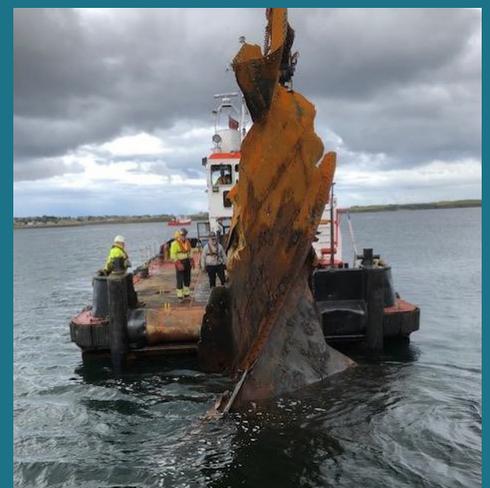
The long reach excavator mounted on a barge has broken up the remains of the vessel. An underwater camera is used to guide this work.

The above photo show pieces of the steel plating which formed the hull, the outer body of the ship, being removed from the sea and lifted onto the barge.

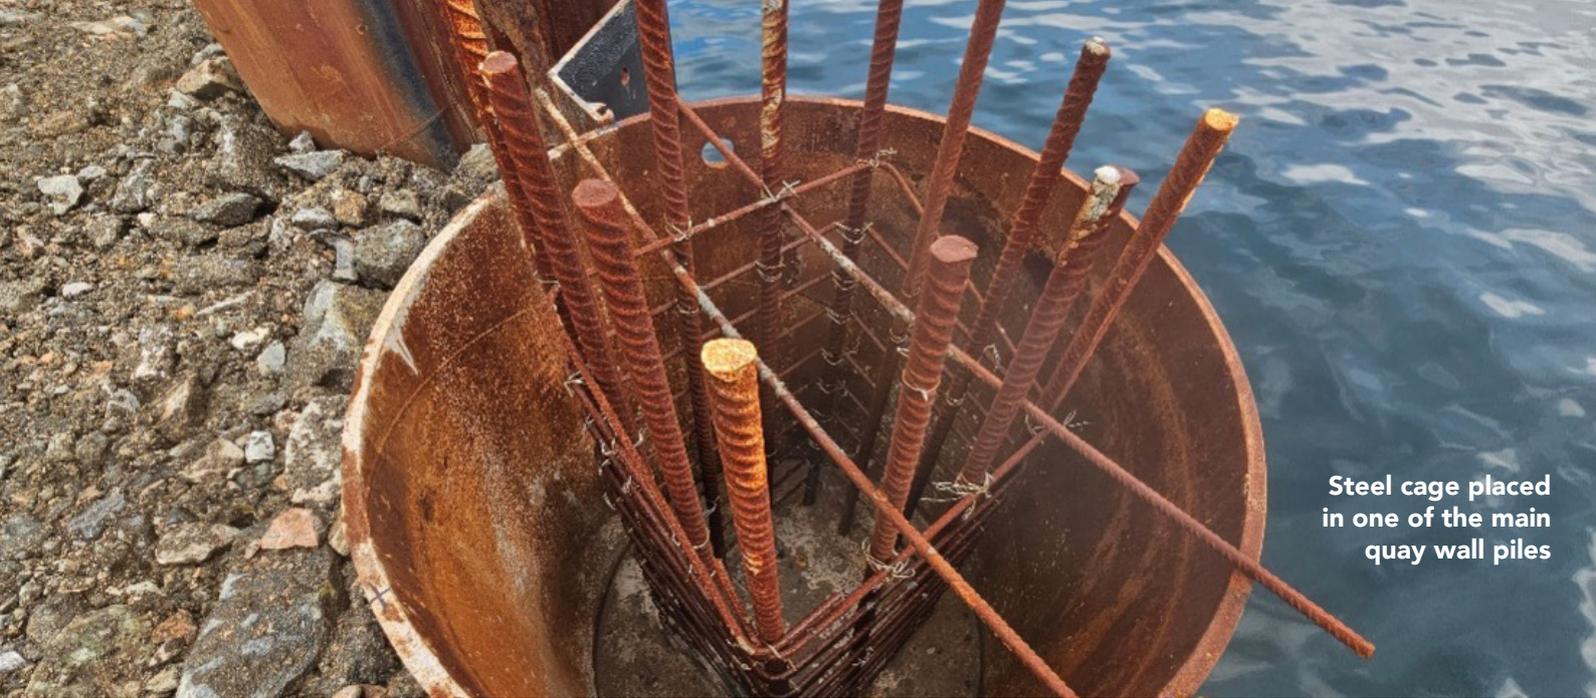
Steel cage placed in one of the main quay wall piles

Next, a 4.5m long 'cage' of steel reinforcing bars is then lowered into the piles. Concrete is then poured around the cage, finishing 1.5m below the top of the pile.

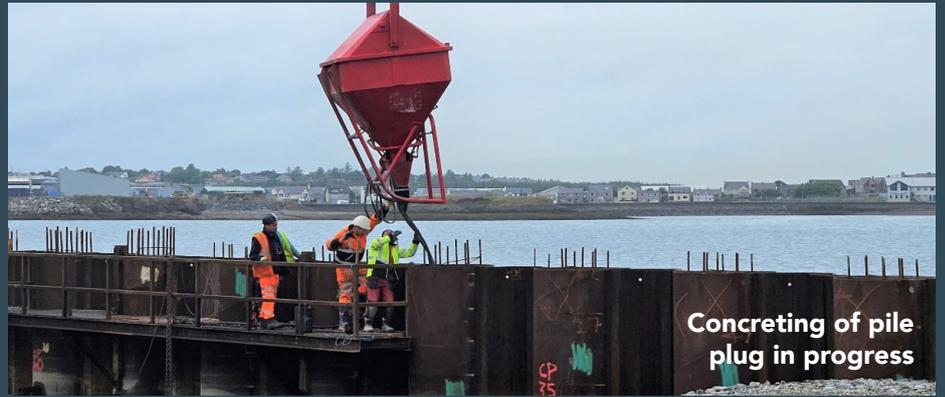
Concreting of pile plug in progress

This forms a plug to the top of the pile, keeping it rigid.

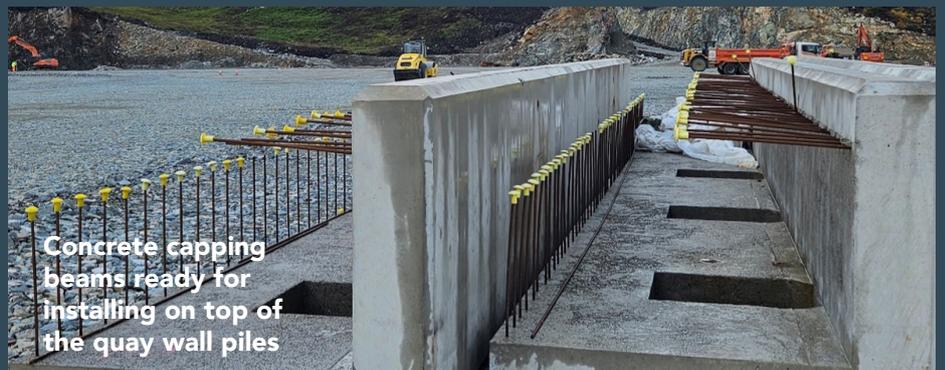
Concrete capping beams ready for installing on top of the quay wall piles

The next stage will involve placing L-shaped pre-cast concrete beams over the top of the piles. These are known as capping beams.
