Diving Report

Alabama Wreck Depth Survey

Wallace Stone
Consulting Civil Engineers

Document Number:
LSK-11001-DR01-R02 – Alabama Wreck Depth Survey

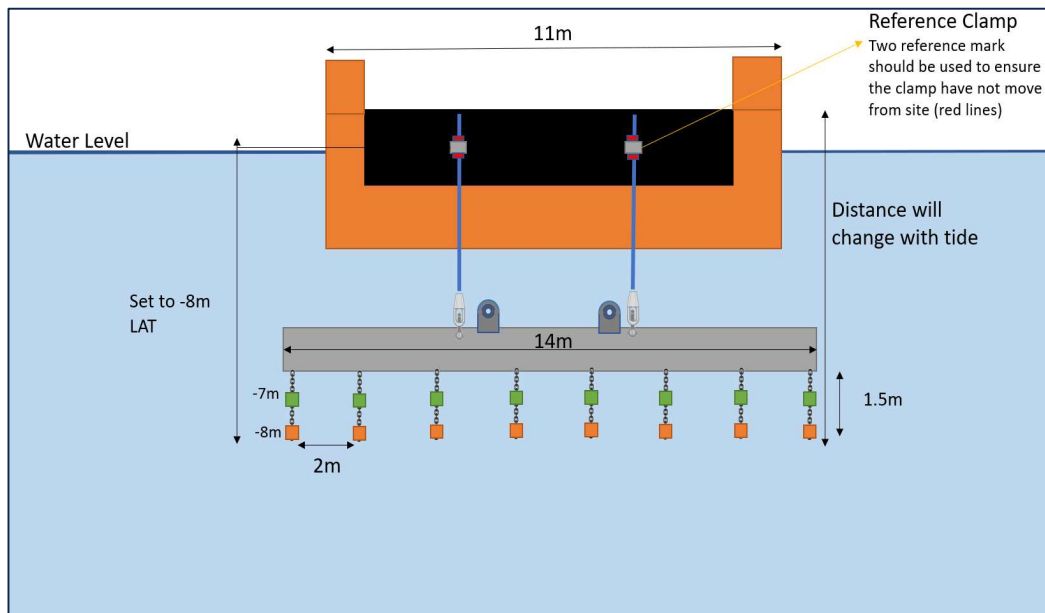
Figure I: Survey Beam Setup

In order to obtain the best results during the survey, Leask Marine identified a swept area of 100m long by 14m wide, surveying up to 2m from each end of the beam where required resulting in a total width of 18m.

To ensure the vessel follows a straight line, we have used the EIVA NaviPac software survey spread for accurate readings of location.

Constant communication was kept between the surveying team and Stornoway Harbour in order to adjust the height of the survey beam according to the tide level relevant to LAT.

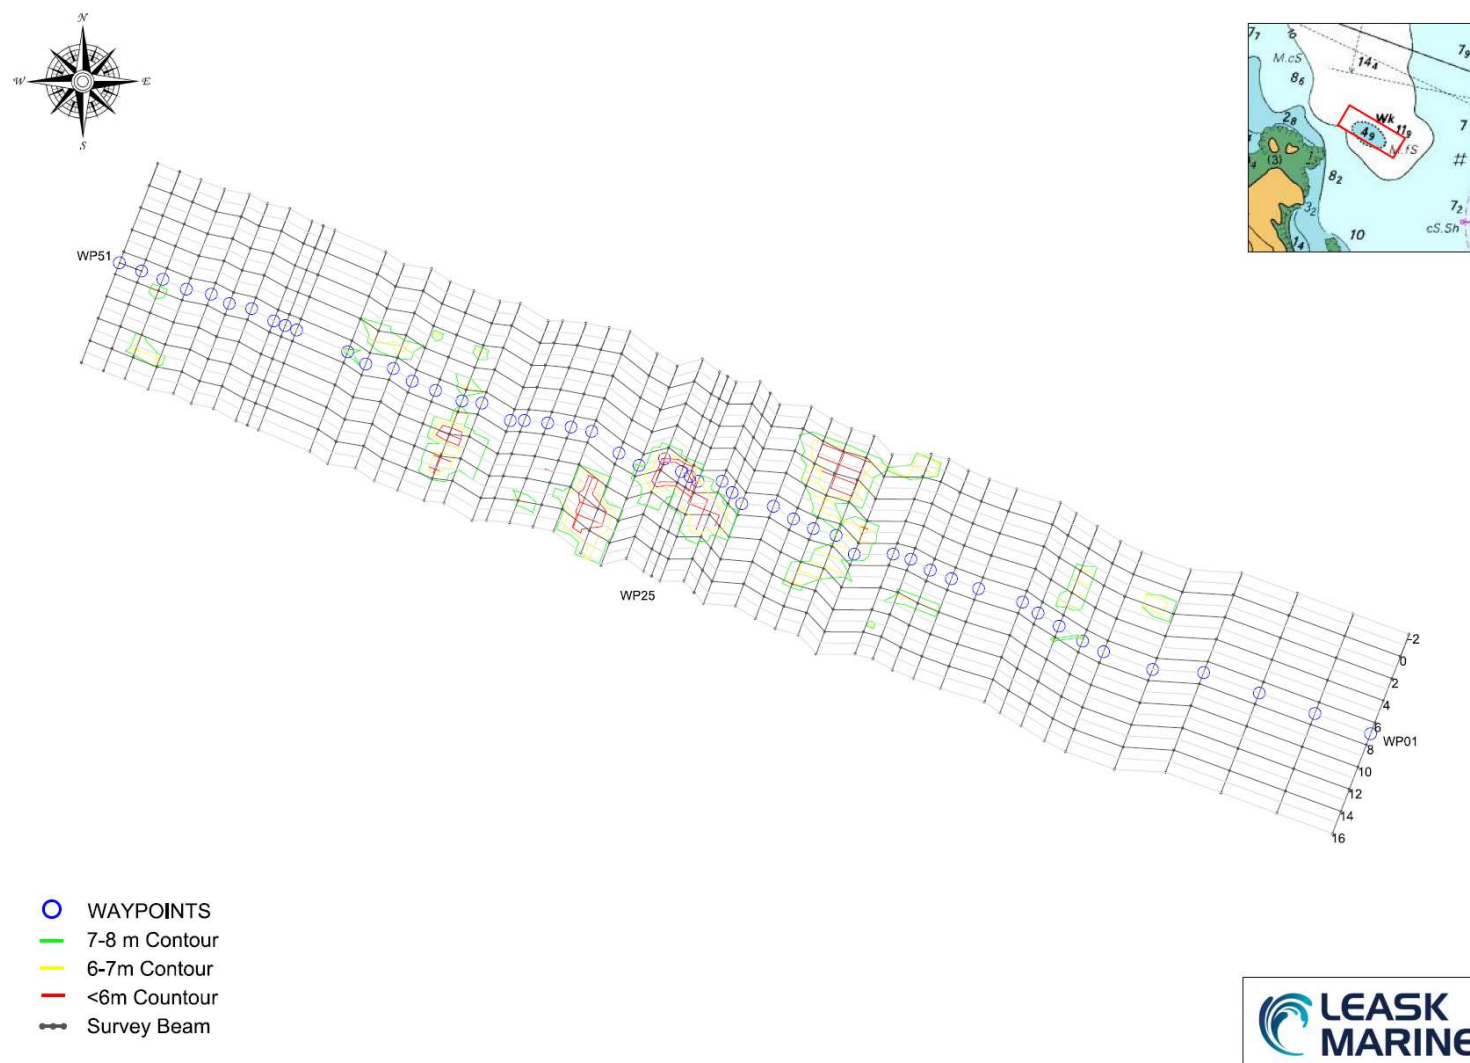
Figure 3: Survey waypoints and Contour Depths

Figure 2 shows the plotted waypoints over the contour level created after the findings of the survey.

Thanks to the figure obtained by combining the waypoints grid and the contour depths it is easier to visualise at which marker and at what waypoint the shallow areas located.

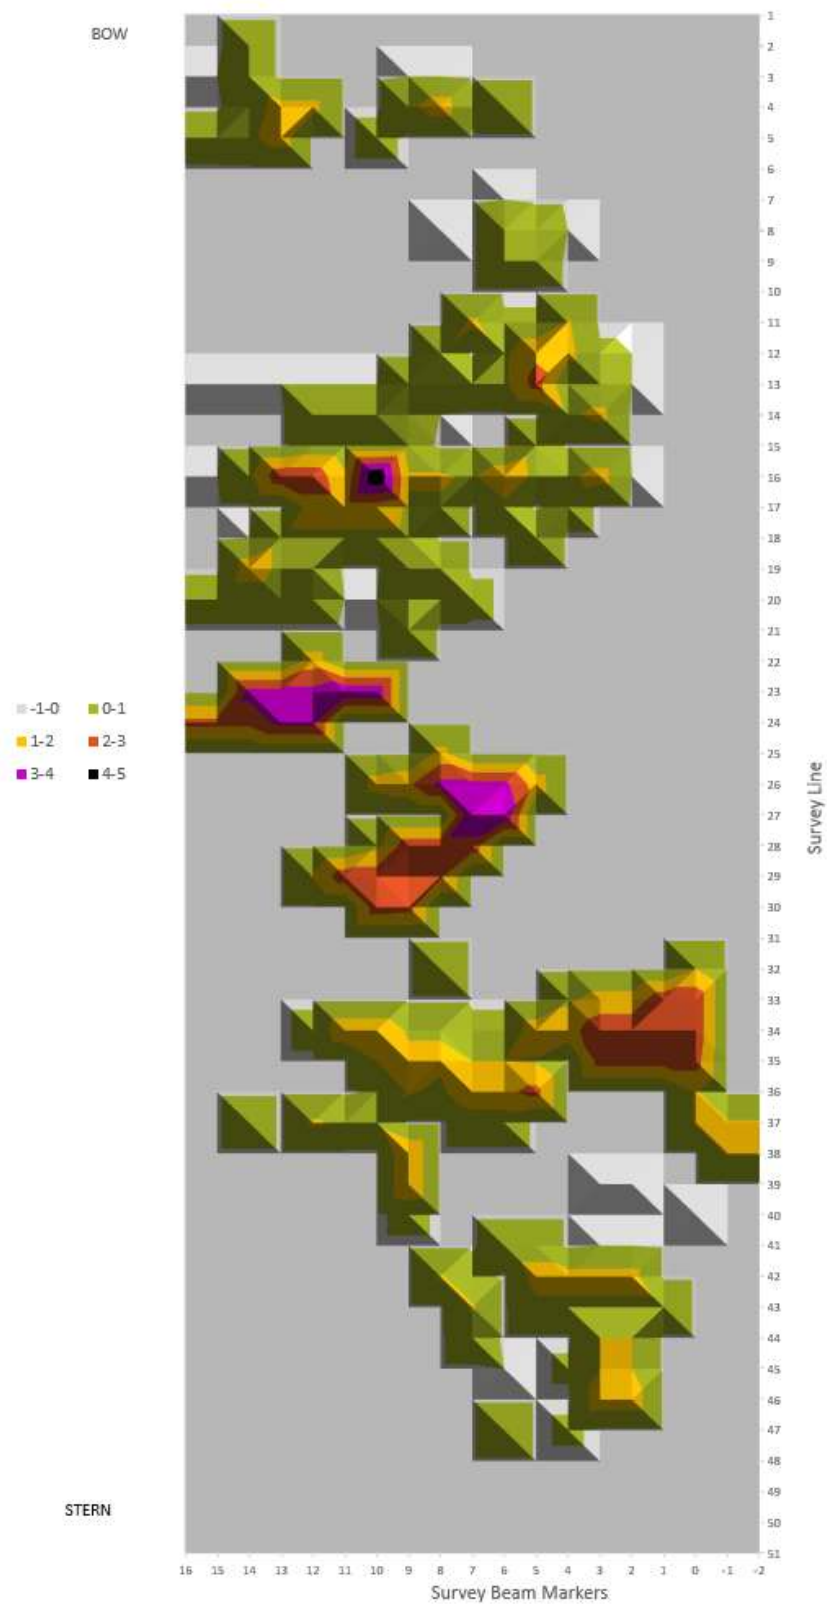
Figure 4: Contour Graph

Represented in the graph below are the contour levels obtained during the diving survey.

- Band -1-0 represent all the areas where no objects were recorded at any of the specified depths
- Band 0-1 represent objects identified between water depth of -8m to -7m (LAT)
- Band 1-2 represent objects identified between water depth of -7m to -6m (LAT)
- Band 2-3 represent objects identified between water depth of -6m to -5m (LAT)
- Band 3-4 represent objects identified between water depth of -5m to -4m (LAT)
- Band 4-5 represent objects identified between water depth of -4m to -3m (LAT)

The graph can be interpreted by the length of material that required to be removed in order to reach -8m LAT water depth.

If the target water depth is -7m LAT, then all the areas in green or grey should be ignored.

The grey areas show the zones where either no objects were found, or the objects are equal or below -8m LAT

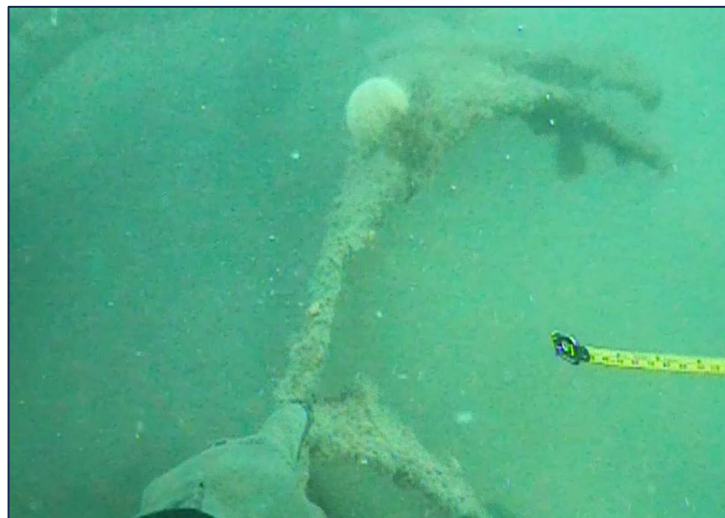
Figure 5: "Flexible" Steel

Some of the identified pieces were "flexible" steel, beams or plates with high concentration of corrosion; however, several other objects still hold a considerable amount of rigidity throughout the wreck.

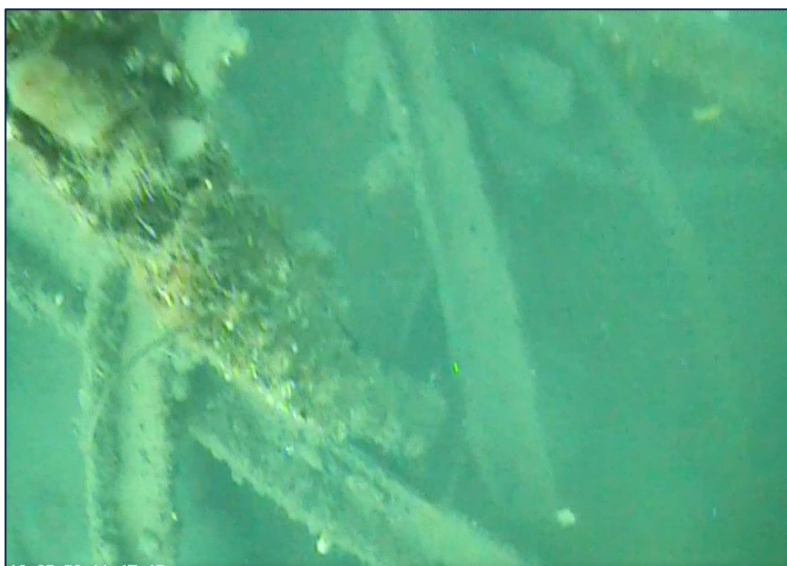
Figure 6: I Beams

The diving team has identified that around 70% of the identified elements are a mix between Angle Iron, I Beams and Steel Plates

The thickness of the steel components ranges from 4mm to 14mm

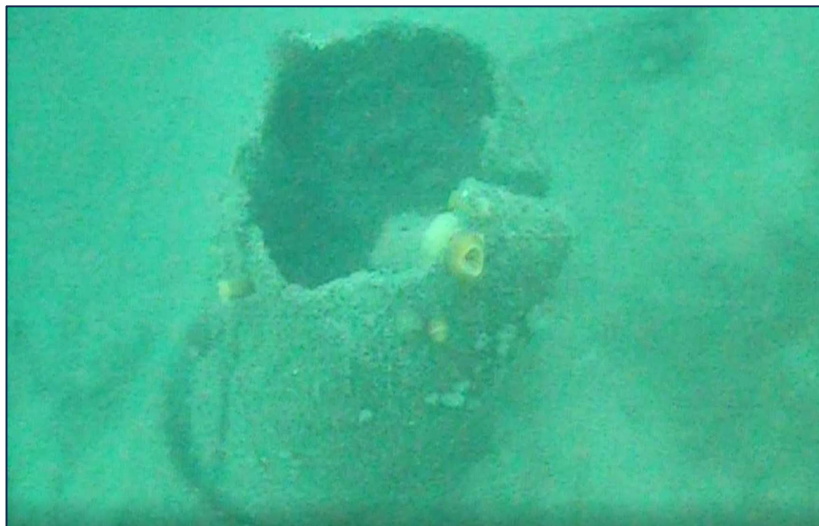
Figure 8: Structure found at WPI6

In WP16, WP17, WP19 & WP26 mixtures of materials identified shown in the pictures below.

From WP16 to WP19, the diving team identified what appear to be the frames of the wreck.

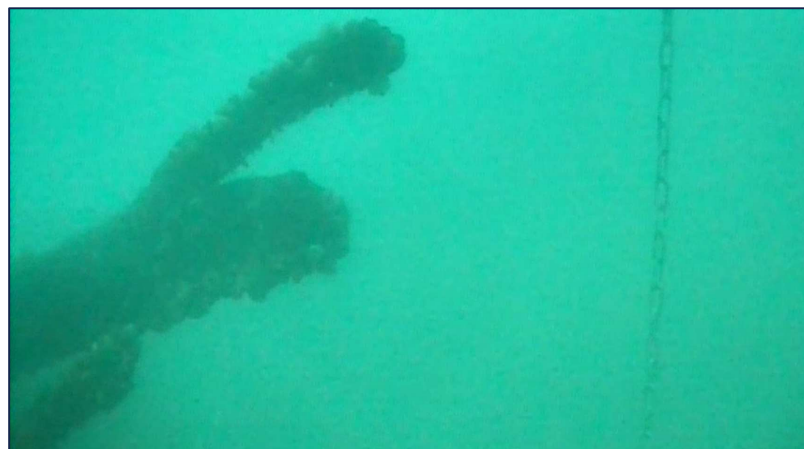
Figure 10: WPI8 Protruding angle beams

WP18 & WP36 contain two of the highest recorded structures during the survey, in both cases an I beam

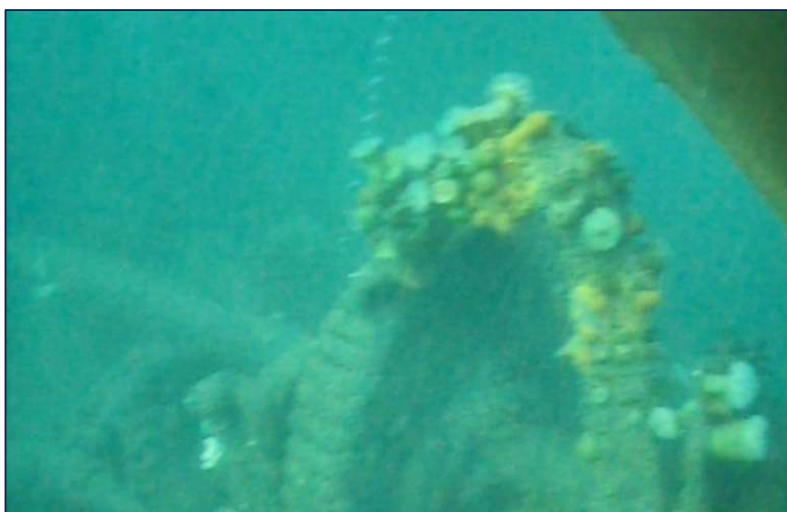
Figure I2: WP26 Remains of a winch

Other details that diving team was able to identify is that the vessel is laying on its port side and some machinery is still on-site as is the case of a vessel winch (WP26) and the propeller of the ship was found at stern of the wreck.

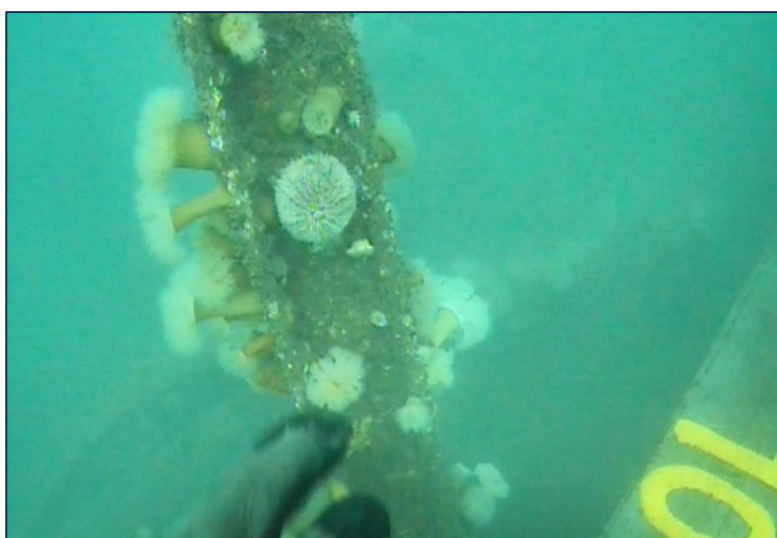
Figure I3: WP36 Highest Point throughout the survey

As previously mentioned, at WP36, the highest object was identified throughout the conducted survey.

An I Beam protruding 3.5m above the survey beam giving a depth of -2.7m LAT at marker 10.

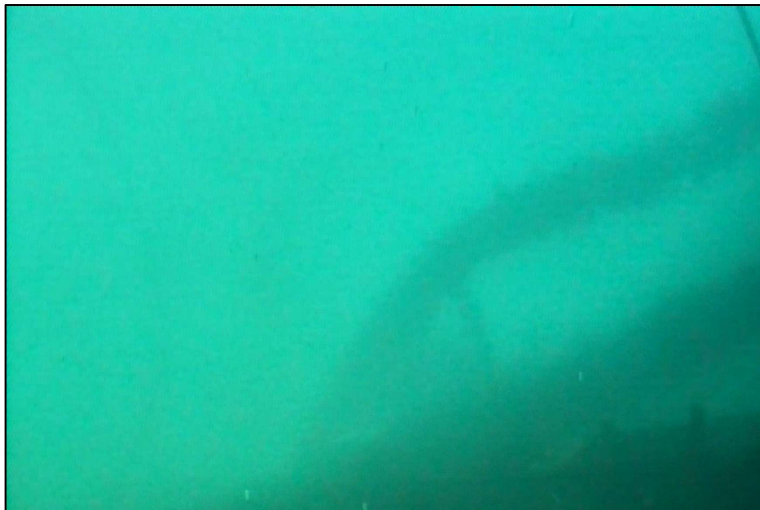
Figure 14: Protruding I beam

During the survey, one of the highest points identified was between markers 6 and 7. It consists of two I beams protruding from the wreck at an angle, both of them rising at WP24 up to WP26 being the highest points as can be seen in Figure 14

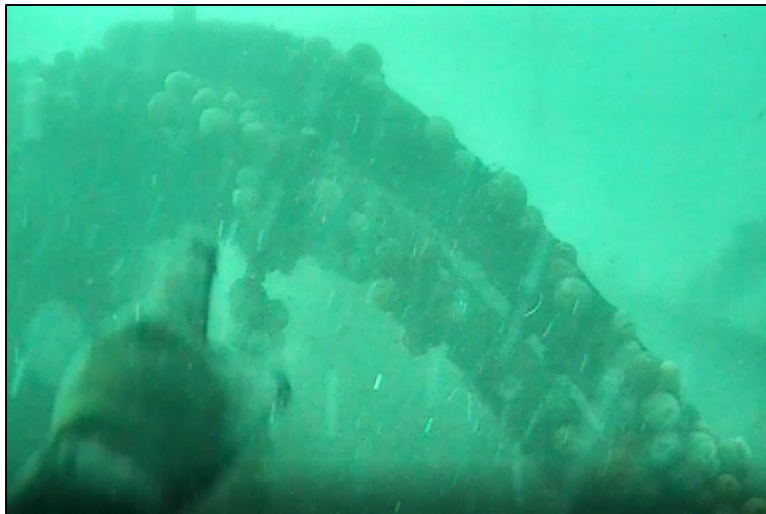
Figure 15: Slope angle after being pushed down

While moving forwards and re-adjusting the height of the survey beam on WP26, both I beams were pushed down by the survey beam to an elevation of -4.7m LAT, Figure 15 shows the slope, shape of the beams after being pushed down by the survey beam.

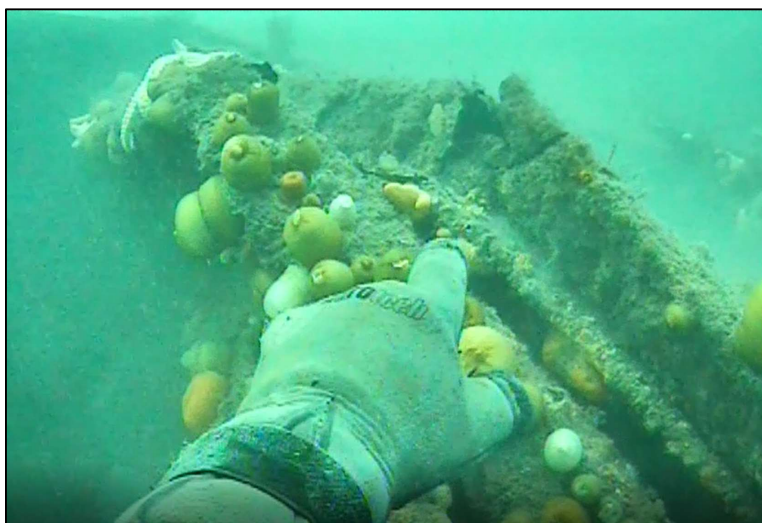
Figure 16: Fracture on I beam

Given that the survey beam was able to push down the steel beams it can be assumed that there is a minimal structural strength on the steel, Figure 16 shows the fracture caused by the bending action.

The steel elements that seem to have less structural strength are angle irons or I/H beams protruding alone from the wreck as is the case of WP 25.

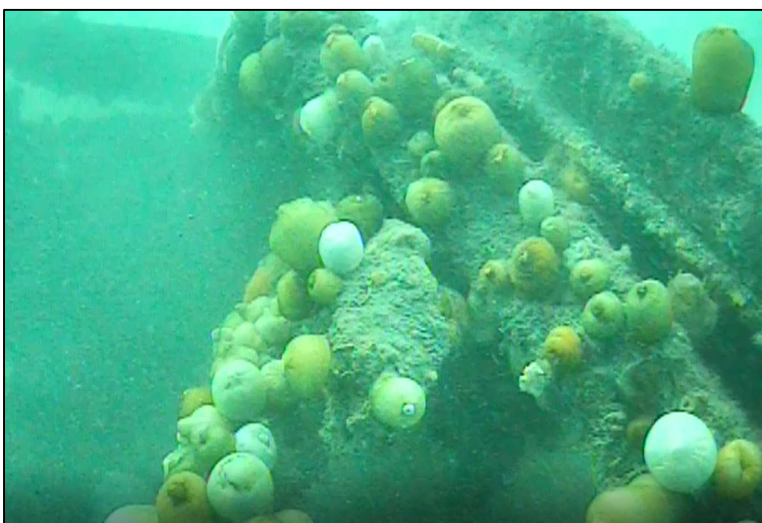
Figure 17: New Highest Point

Figure 16 & Figure 17 show the new highest point at WP25 previously recorded at -3.5m at marker 6 and -3.2 at marker 7, these dimensions have changed as the survey beam pushed down on both I beams by approximately 0.5m giving a new height of -4.2m at marker 6 and -4 at marker 7.

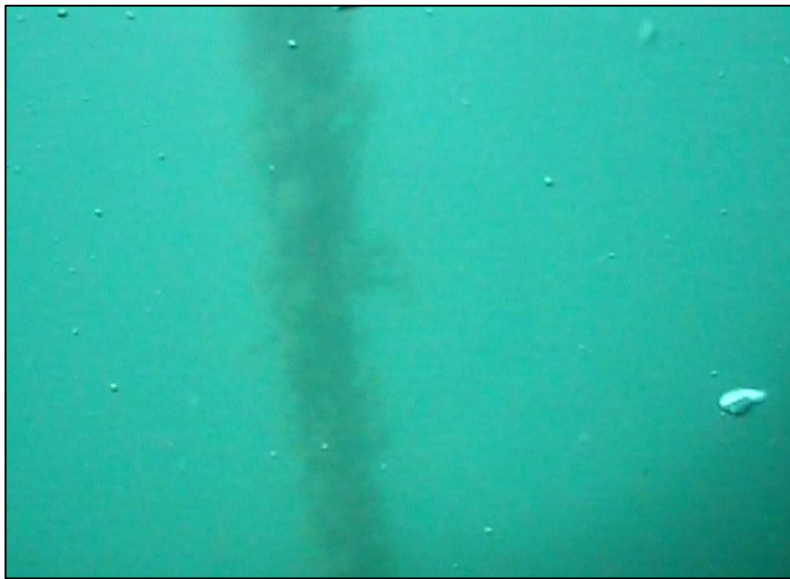
Figure 18: I beam WP36

The I beam can be described as rigid and fix at the base and extend out through water column to the surface where is not stable

The first hotspot (#1) only cover from WP35 to WP36, making it the smallest hotspot, covering a total distance of 2m, and from marker 8 to marker 13 on its widest part (6m) at the middle of this area the divers found the highest point of the survey at a water depth of -2.7m LAT. (Figure 18: I beam WP36).

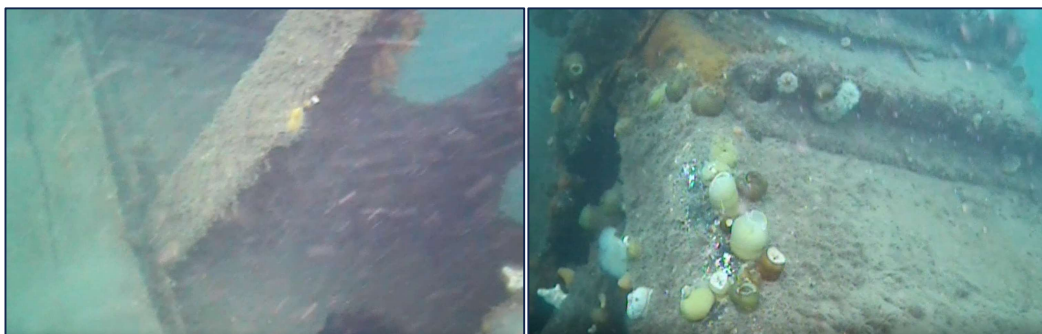
Figure 21: Wreck Frames

The last hotspot (#4) contains what the divers identified as the most prominent and most substantial structure of the survey, the frames sections on the wreck (WP16 to WP19).

The frame sections were described as a thick double steel plate structure, with considerable rigidity

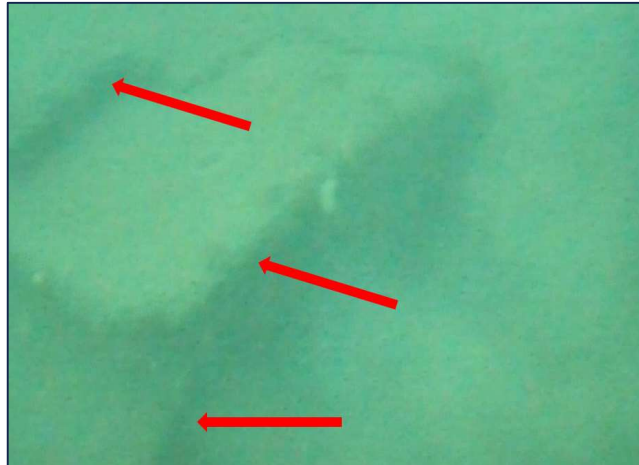
Figure 22: Overlapped steel plates

The second area starts at WP37 to WP41 where the diver found a mix of different plates thickness overlapping each other, which complicates its removal.

Another consideration noted from the diving team is that in more than one location it is only visible a hard steel sheet, without knowing what kind of structure support might be laying underneath.

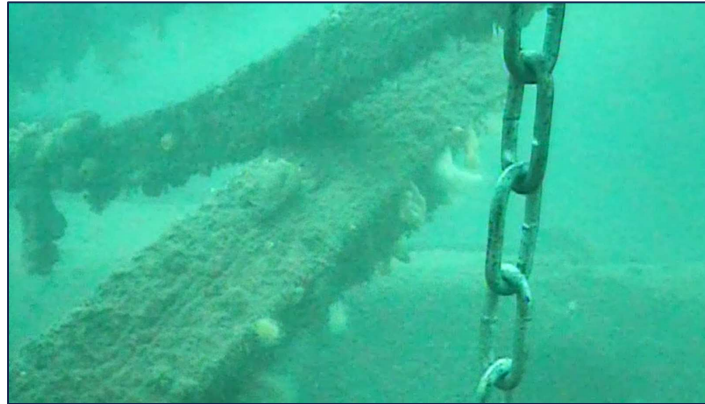
Figure 23: Crossed-over Steel beams

Towards the middle of the wreck we found the zone with high concentration of cross over between angle iron beams and I beam.

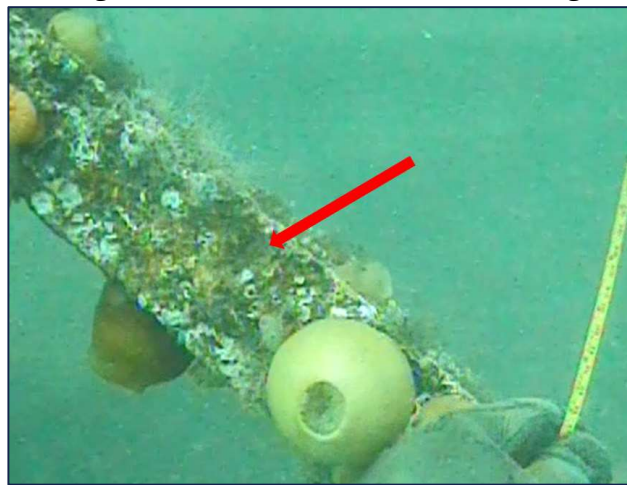
Figure 24: Corrosion on steel

The divers noted that a high level of corrosion is visible throughout the steel of wreck
